# Rocket Science

Experiences In The Space Trade

Norm Walker

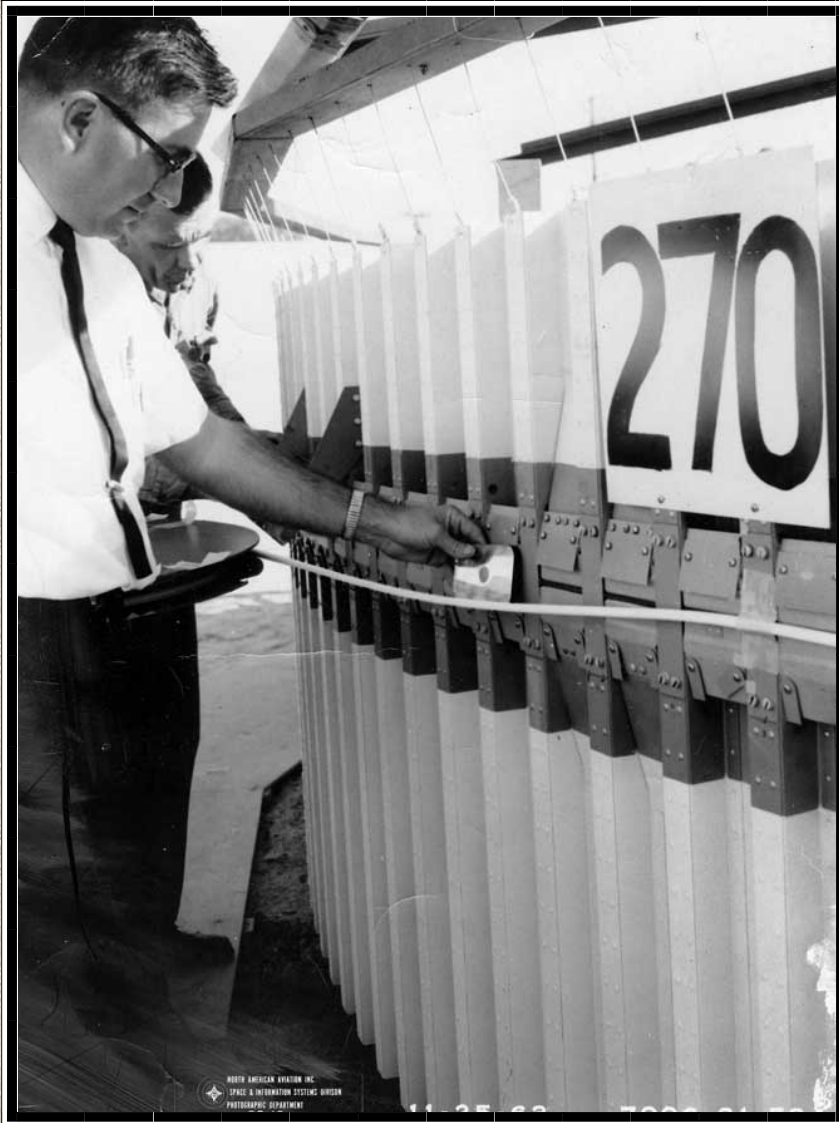
## S-2 FULL SCALE SEPARATION TEST (Photo From Private File)

This is a pre test photo of a full scale separation test conducted at El Toro, CA in November, 1963. The photo shows the installation of a preliminary design Linear Shaped Charge Assembly on a test fixture. The fixture simulates the structure of the two separation planes on the Saturn 2nd stage.

The LSC Assembly was later redesigned several times and tested extensively in environmental conditioned test set-ups, but in a straight line. One of the objectives of this test was to evaluate the feasibility of installing the LSC assembly in the manner shown in the photo\*. The reel of LSC was mounted on a wheeled cart and rolled around the simulated interstage, completing attachments along the way. This same basic method was later used at the VAB (Kennedy Space Center) for LSC installing on flight vehicles.

\*Tape was substituted for LSC hold-down clips which were not yet available for the test. The mirror was used to examine the fragile LSC element inside the Teflon backing for damage.

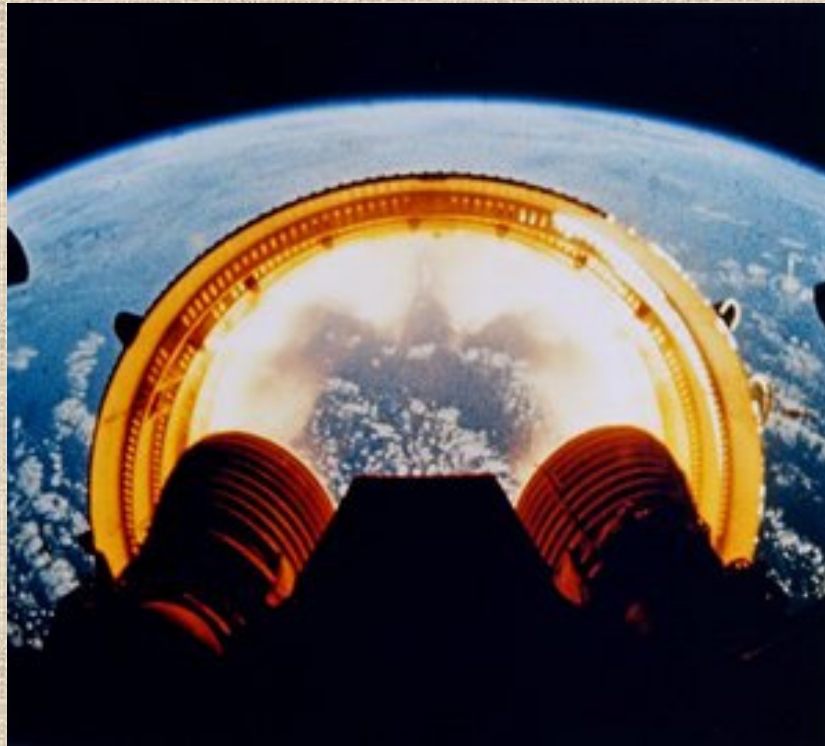
### **Flight Photo of SII 2nd Plane Separation**

This is a photo of the real thing. First plane separation had occurred 30 seconds earlier, (detaching the 1st stage). 2nd plane separation occurred just a moment before this photo frame was registered. The photo shows the 11 K Lb. interstage dropping away from the S-II (thankfully without wrecking the mission). Whew!! What a relief !

An early Saturn V launch had cameras installed in the aft portion of the S-II stage. The above still is from the movie film taken of interstage separation. The film package was jettisoned and recovered via parachute. There were 13 total Saturn V launches, the last one for Skylab having only two propulsive stages. On this launch, debris from failed Skylab components disabled the 2nd plane separation LSC. This resulted in unplanned retention of the interstage on the S-II, but caused no problem to the Skylab mission.

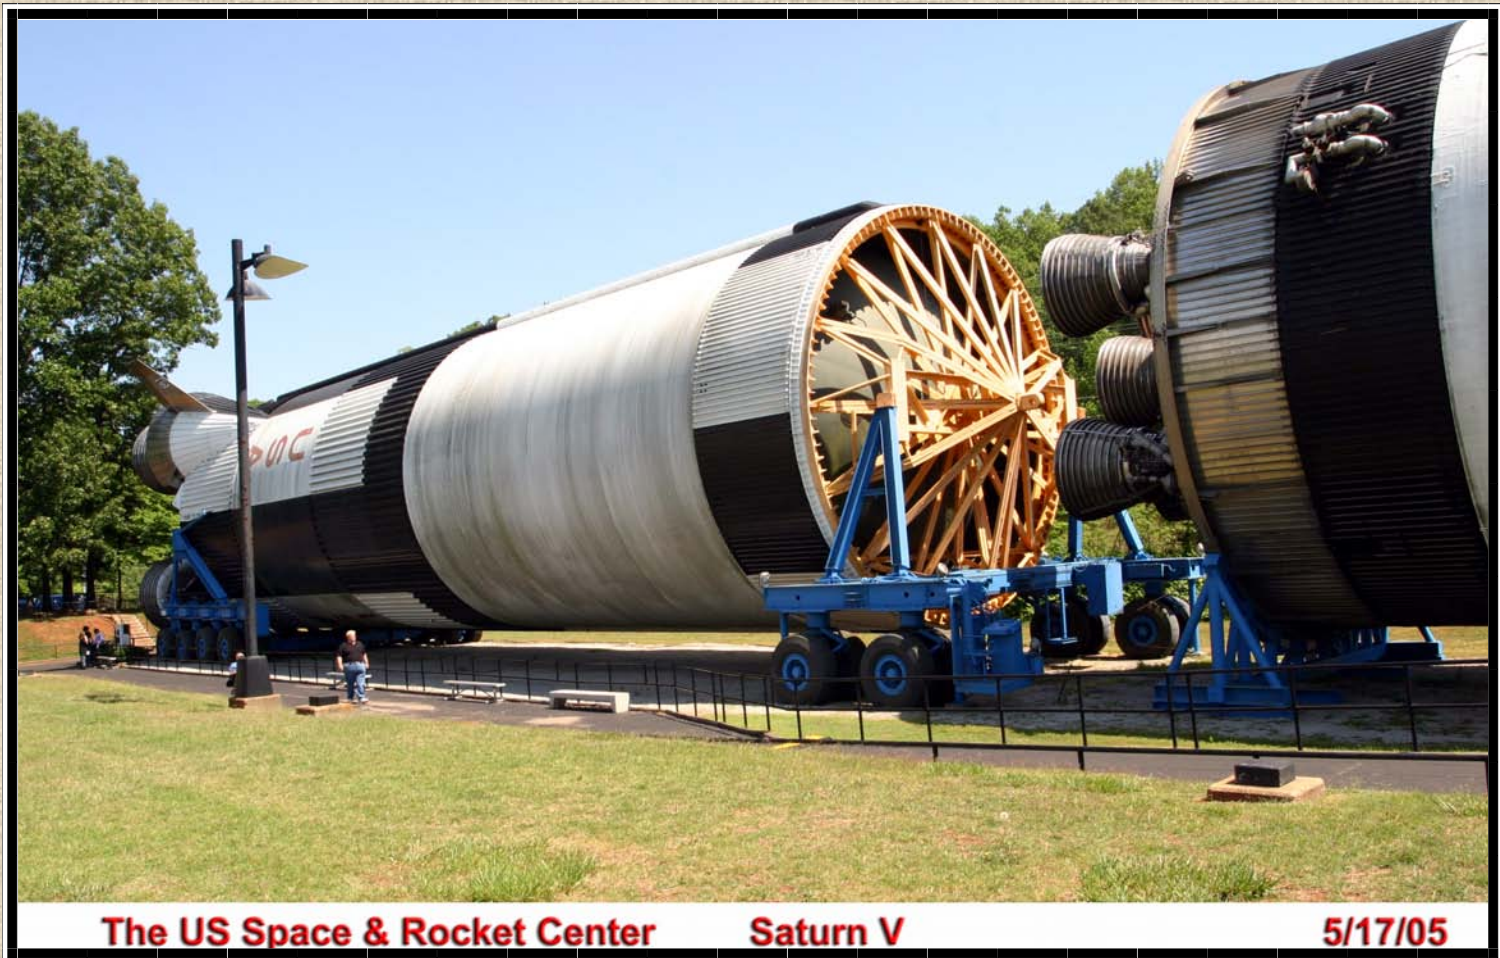
View of the first and second stage interface, without the interstage. The actual Saturn flight vehicle had a 11,000 pound interstage ring structure to connect the two stages. The interstage was tall enough to house the five 2nd stage engines showing in the photo. At the end of 1st stage burn, the spent stage was separated just below the 2nd stage engines. To have separated any higher would have risked damage or destruction of the engines during the separation process. Eight retro motors mounted aft on the departing 1st stage helped to achieve clean separation. startup of the five J2 2nd stage engines was aided by the firing of eight ullage motors mounted on the interstage. The purpose of this was to settle the 2nd stage propellants for trouble free propellant feed into the turbo pumps. After 30 seconds of 2nd Stage burn, the interstage was separated just above the engines and below the S-II propellant tankage. This got rid of unneeded weight and also avoided overheating equipment mounted in the 2nd stage aft section. The total separation process was called "dual plane separation". The main load across the separation interfaces was compressive so the joints were designed with butted compression fittings and only individual .080 inch thick aluminum straps (218 of them) provided tensile strength. This enabled the relatively small linear shaped charge (LSC) device to cut the straps at the appointed time. The LSC was small in cross section but was over 100 feet in length to reach around the 33 foot diameter of the separation plane. For the dual plane separation two LSC assemblies were needed, the second activated 30 seconds after the first.

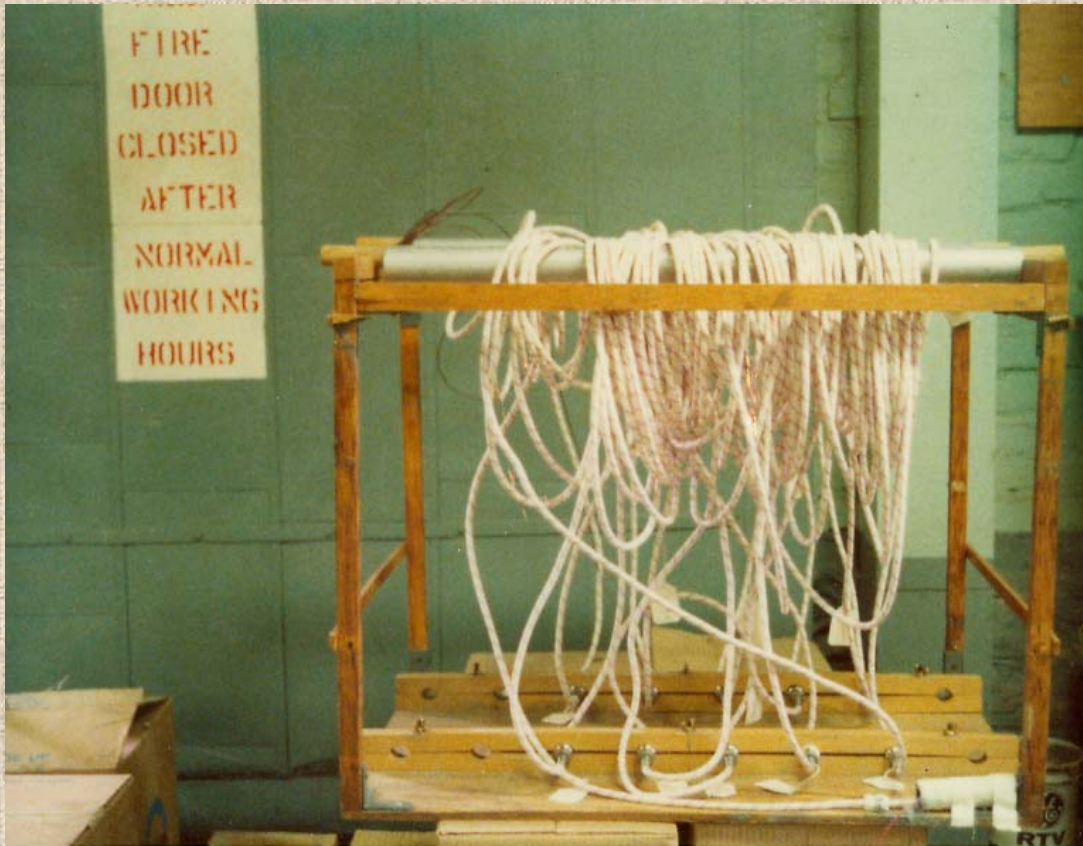
1972 CDF Vibration Testing

**One of the components we furnished for the Saturn program was an ordnance item called the CDF Assembly. One of our tasks was to monitor production acceptance testing. This required frequent traveling to test labs around the country. The CDF Assemblies were manufactured in Connecticut. Environmental testing , including vibration shown here was conducted in New Jersey, near the present day NY Giants football stadium. Only a small batch of specimens can be tested at a time. It takes hours to work through a typical batch of samples from a production run. . Shock testing must be done also. Temperature Humidity testing takes 2 weeks but once the parts are put in the chamber, everything is automatic.**

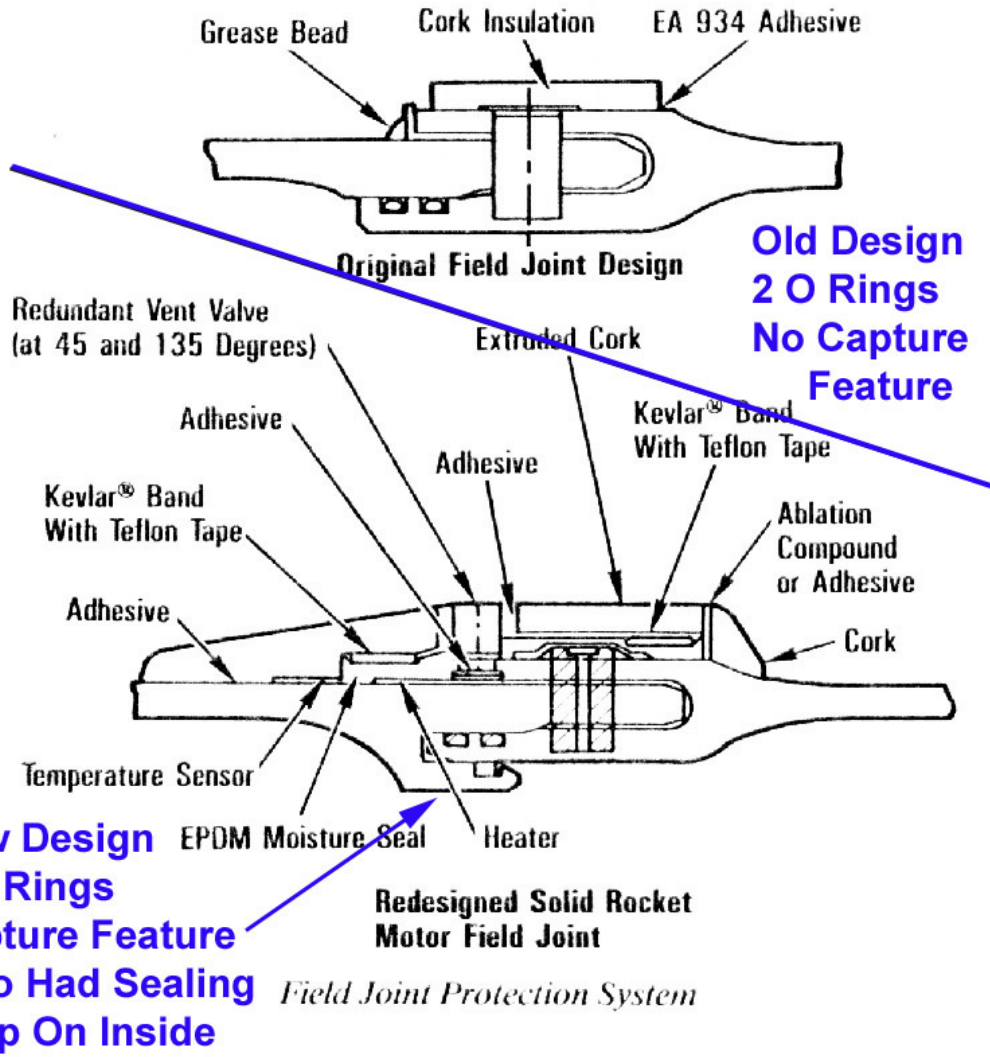
# SOLID ROCKET MOTOR CLEVIS JOINT

The J Flap was added to the redesigned SRB field Joint in addition to the 3rd O Ring which is called a "barrier" rather than a seal. The J Flap hangs down slightly and forms a tight seal with its mating surface then the two SRM segments are brought together. Also adhesive is applied to the lower surface before mating. On ignition and case pressurization, the flap is pressed more tightly to its mating surface -- like the bead on a tubless car tire. s
